MEMORANDUM NO. 2011-024

SUBJECT: Proper Disposal of PCB-Containing Fluorescent Light Ballasts

Proper Maintenance, Removal, and Disposal of PCB-Containing Fluorescent Light Ballasts

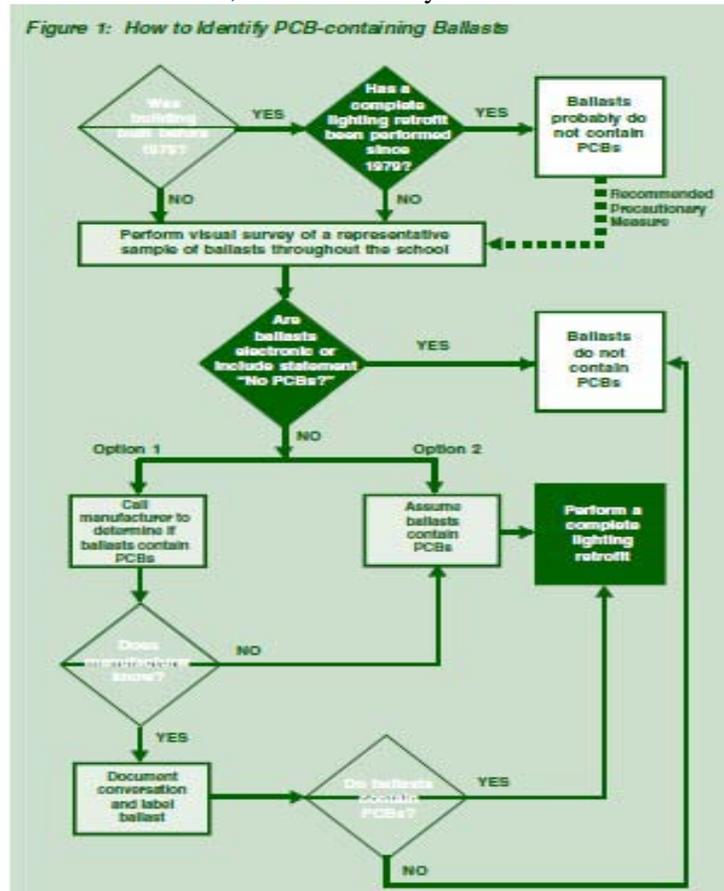
Figure 1 can help you determine whether there may be PCB-containing ballasts in your school. The ballasts are contained within the light fixture (see photos on page 1). Because you may need to remove the fixtures to view the ballasts, select a representative number of ballasts throughout the school to inspect first. Inspection may also be accomplished by removing a portion of the fixture, such as the metal panel covering the ballast. Expand your inspection if you find PCB ballasts. To prevent exposure if leaking ballasts are discovered, wear protective clothing, including chemically resistant gloves, boots, and disposable overalls. Make sure the survey is performed in a well-ventilated area, or provide supplemental ventilation or respiratory protection if necessary to reduce the potential for breathing in fumes. Be sure to keep a record of the areas (e.g., classroom 101) and location of the lights surveyed.

1. If the ballasts do not have the statement “No PCBs,” you have two options: Assume that the ballasts contain PCBs, OR
2. Contact the manufacturer to determine whether the ballasts contain PCBs. If the manufacturer is not sure whether the ballasts contain PCBs, assume that they do.

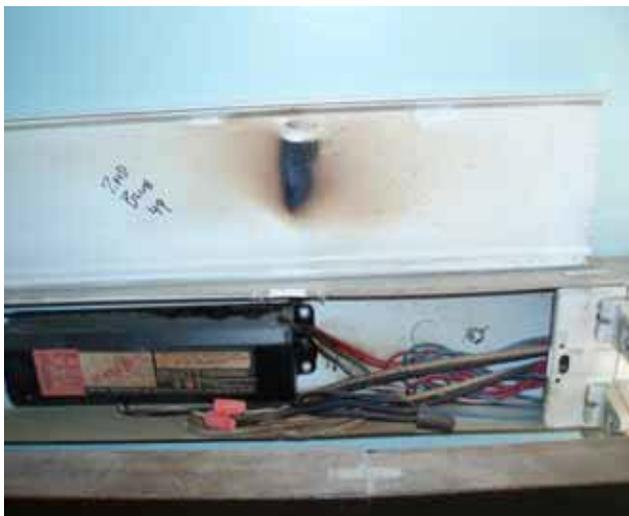
Unaware that the old fixtures contained PCBs, the district had been taking them to another local school to be dismantled. The EPA discovered that the old fixtures were not being handled properly, and that the leaking PCB ballasts were actually being stored on the school's playground. In addition, the workers handling the leaking ballasts were not trained in the proper handling of PCB waste materials. Lack of awareness of the problem and mishandling of the response needlessly exposed students, staff, and maintenance workers to PCBs.
